Products Affected:

- VG4 AutoDome Modular Pipe Mount kit
- VG4 AutoDome Modular Roof Mount kit
- VG4 Pipe Mount Interface Board (VG4-A-9543) without a visible date code stamped as shown in Fig. 3.

1.0 Issue

VG4 Series Roof Parapet and Pipe Mount installations have the potential for moisture ingress into the AutoDome due to

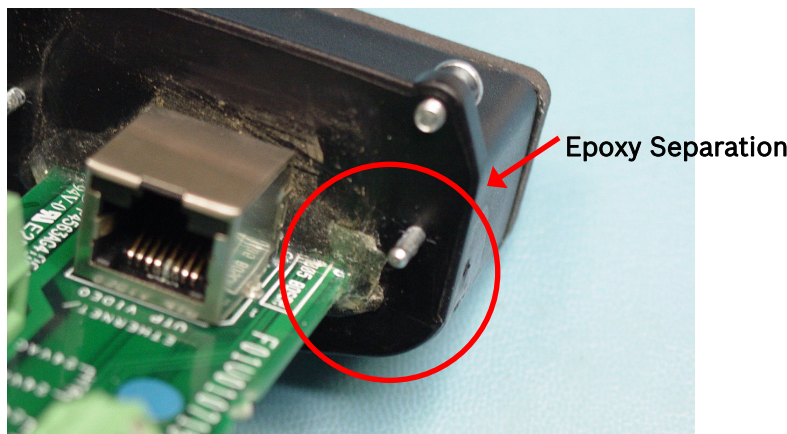
Water leaking through the assembly can affect the Pipe Mount Interface board. A manufacturing defect that caused an epoxy separation on the boards may allow moisture to enter the pendent and could cause the AutoDome to fail.

The epoxy that adheres the Pipe Mount Interface Board to the rest of the assembly can fail. This issue may cause the AutoDome to fail and may induce corrosion.

Figure 1: VG4 Pipe Mount Interface Board showing Epoxy Separation

This section provides information for obtaining a new VG4-A-9453 Pipe Interface Board. If you notice epoxy separation or are experiencing water ingress, contact Bosch Customer Service at 888-289-0096 for a return authorization. Bosch will send you a replacement a Pipe Mount Interface Board, at no charge.

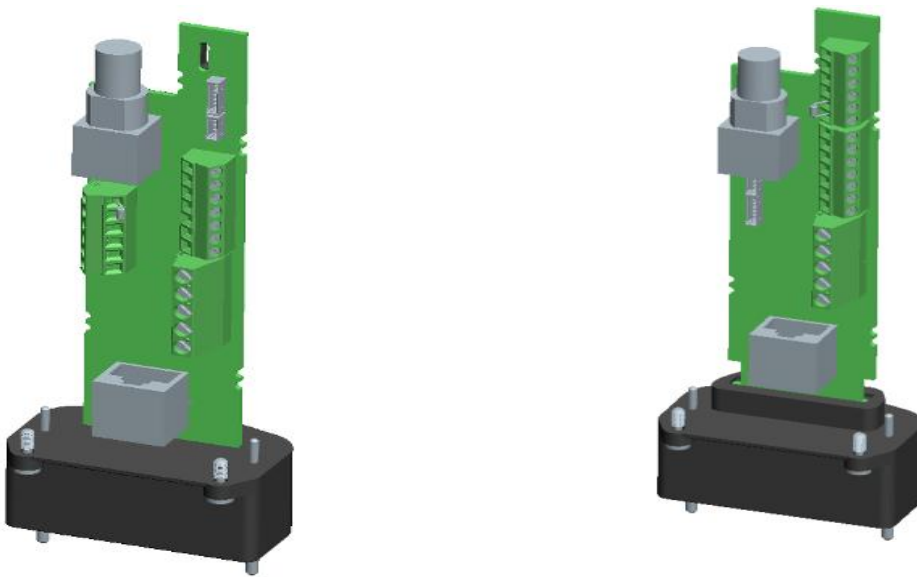
The physical layout of the VG4-A-9453 Pipe Interface Board has been redesigned to eliminate the effects of water inside the pipe. The base of the Pipe Interface Board has been extended to shift the seal location higher in the pipe. This raised seal also prevents the flexing of the board from damaging the seal. This change has been implemented and the new design began shipping in July 2009.

Figure 2: VG4-A-9453 Pipe Interface Board: original design (left) and new design (right)

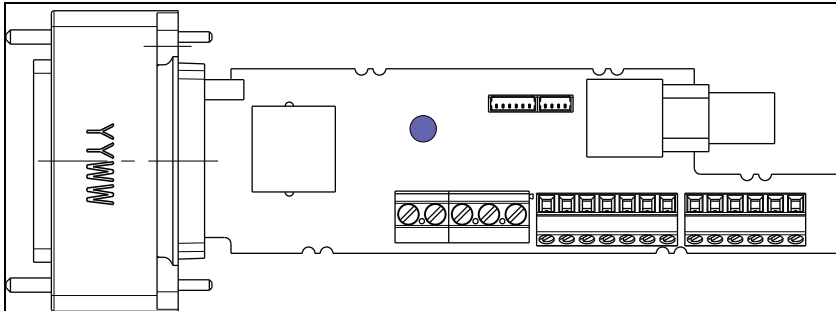
The new design is distinguished with a “blue dot” label on the board and has a Date Code stamped onto the black over mold at the base of the assembly. The Date Code is in the YYWW format, where YY is the 2 digit year and WW is the 2 digit week. For example, the date code 0918 is week 18 of 2009. The original design did not have the raised edge and does not have a date code.

Figure 3: New VG4-A-9543 Pipe Interface Board
