**Release Notes for  
Version 8.05/8.14**

**November 2011**

# D9412GV3/D7412GV3/D7212GV3

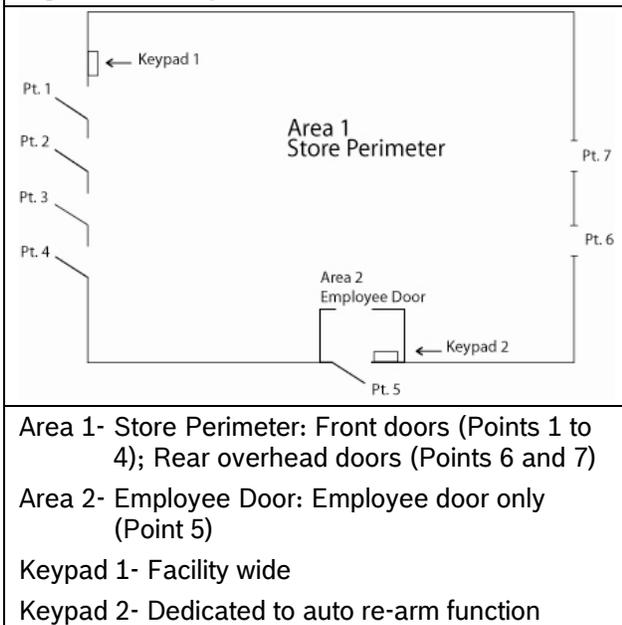
**Figure 1: Example of Auto Re-Arm Feature**

The Auto Re-arm function provides the ability to automatically re-arm an area after disarming. For instance, the feature could be used to create an Employee Door area that could be used to allow employees to enter and exit without having to disarm the entire perimeter. Refer to Figure 1.

An area cannot be disarmed without automatically rearming from a keypad dedicated to the auto re-arm function.
